AVIATION INVESTIGATION REPORT

A04Q0089

RISK OF COLLISION

QUÉBEC/JEAN LESAGE INTERNATIONAL AIRPORT, QUEBEC

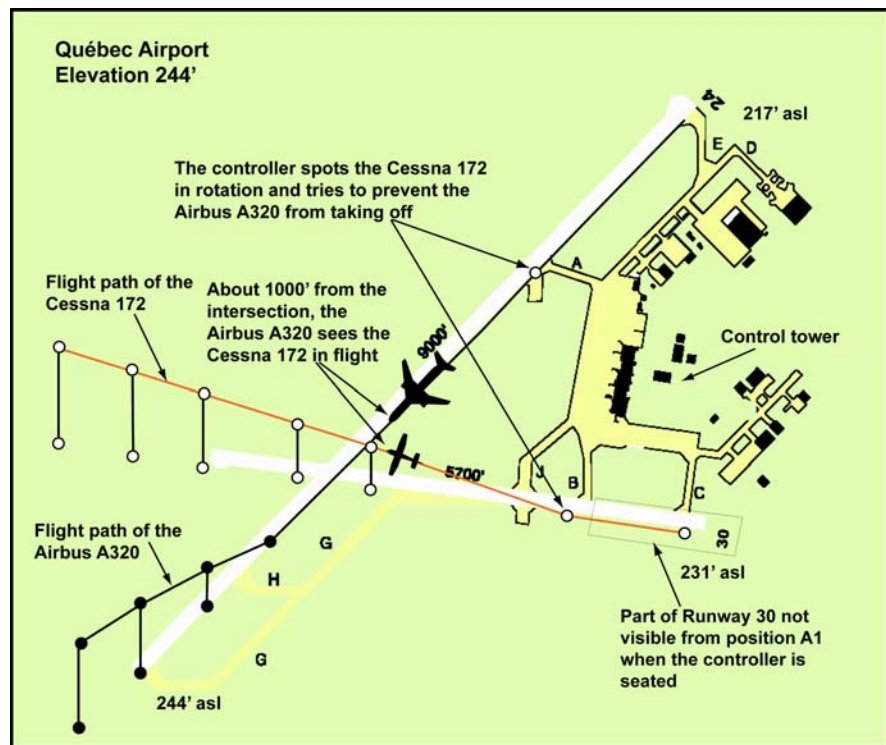
Figure 1. Flight path of the aircraft

At 0935:20, about 1000 feet from the intersection of runways 24 and 30, when the Airbus A320 had reached its rotation speed (146 knots), the captain saw the Cessna 172 in flight on a converging track. He immediately ordered the co-pilot, who was at the controls, to delay the rotation and to not take off until they had crossed Runway 30. Radar data show that the Cessna 172 flew over the Airbus A320 with 200 feet of clearance above the intersection of the two runways.
